### SERVICEORDRE – 2011-3

<b>HENVISNING:</b>	UPT Servicebulletine # 20110523, 23 mai 2011
<b>FORMÅL:</b>	Kontroll av søm som fester ryggkrysset til containeren
<b>STATUS:</b>	<b>Obligatorisk</b>
<b>IDENTIFIKASJON:</b>	Alle Vector 3 Sport og SE (elevutstyr).
<b>BAKGRUNN:</b>	En elev opplevde en meget hard åpning som igjen medførte at reservecontaineren løsnet fra innfestingen til ryggkrysset. Dette satte i gang en hendelsesrekke som til slutt resulterte i en to skjermisituasjon med påfølgende kutt i lav høyde. UPT mener at sømmen som fester containeren til ryggkrysset må ha vært skadet på forhånd, noe også kontroller har vist.
<b>SERVICE:</b>	Sømmen som fester containeren til ryggkrysset skal undersøkes av MK/MR. Ved skader på sømmen skal riggen til MR for reparasjon/omsyng. For detaljerte instruksjoner, se under.
<b>UTFØRELSE:</b>	Før neste hopp. Kontrollen utføres av MK/MR. Reparasjon utføres av MR. Ved kontroll når alt er i orden, påføres riggens kontrollkort SO 2011-3 kontroll utført ok. Ved reparasjon påføres SO 2011-3 reparasjon utført. For rigger som kun blir kontrollert, må MK ved fremtidige hovedkontroller sjekke sømmen.

SERVICE BULLETIN #20110523

SUBJECT: Inspection of

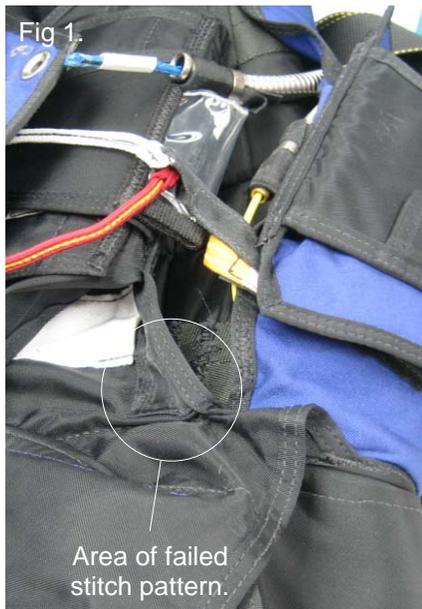
BACKGROUND: It was reported that a student jumper after pulling at a planned altitude of 5000', experienced a very hard opening and broke the upper double zigzag stitching that holds the diagonals in place and tore most of the ring cover off (See Fig1). This allowed the large ring riser attachment to be pulled far away from its normal position, deforming the over the shoulder section of padding and in turn pulled the RSL lanyard releasing the reserve pilot chute.

NOTE: It is unlikely this stitch pattern failed completely on this one jump, but was damaged on other prior jumps and completely failed on this one very hard opening. Further inspection of other Vector SE containers at the same DZ revealed other diagonals with various stages of stitch failure in need of repair.

**SERVICE BULLETIN:** Before the next jump it is strongly recommended that all jumpers inspect this area for broken stitching. This can easily be done on packed rigs by simply opening the reserve pin cover and riser cover, then work your thumb up under the diagonal to expose the zigzag stitching. Only the top inside section of stitching needs to be inspected (Figure 3). Consult your local rigger if you are unsure or have any questions.

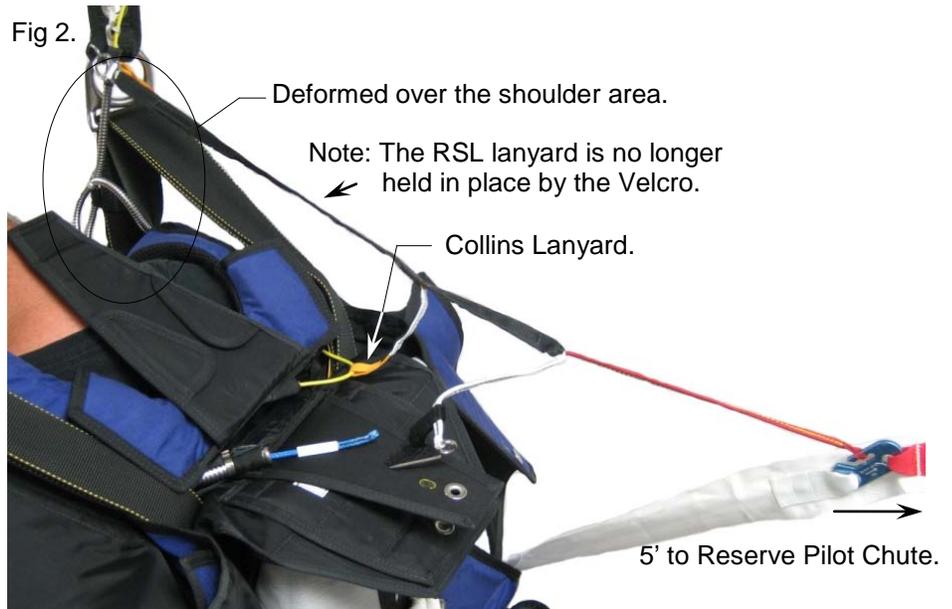
At an altitude of around 4500' the attachment point of the SkyHook and RSL lanyard produced a trailing reserve pilot chute (*preventing a two out scenario*) as witnessed from the ground (See Fig2). At an altitude reported to be between 225' and 250' the student jumper initiated a final approach turn, but due to the deformation of the right shoulder section of the harness, the Collins lanyard released the left riser from this turn input (See Fig2). The student then reacted by immediately pulling the cutaway handle releasing the right riser initiating a SkyHook direct bag deployment. After a very short reserve canopy ride, the student experienced a hard landing in a corn field.

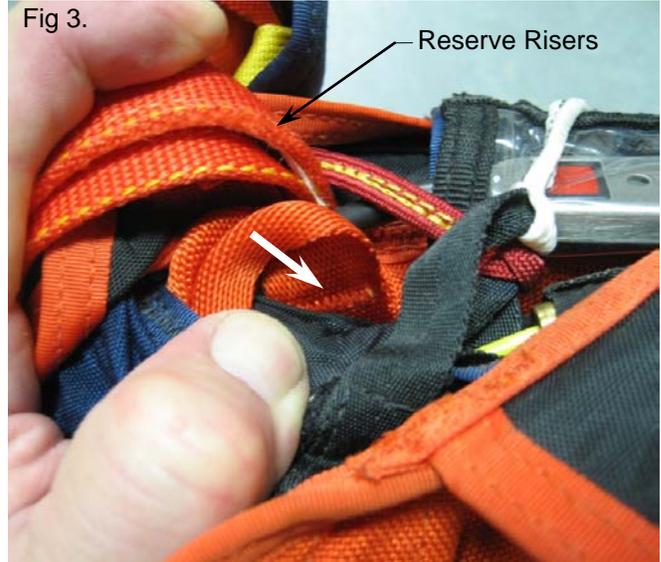
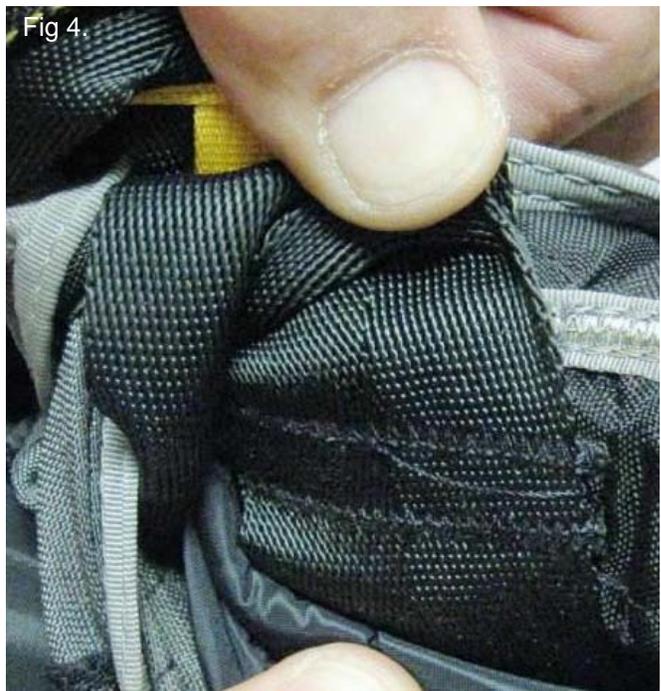
Figures 3 and 4 show examples of undamaged stitch patterns. Undamaged stitch patterns such as these do not require repair.

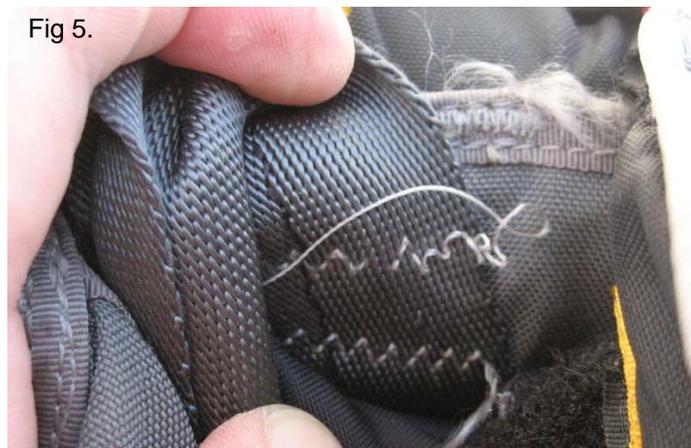
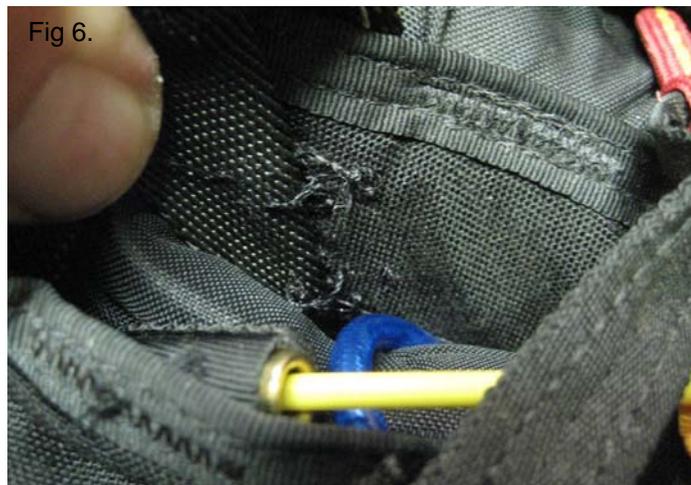
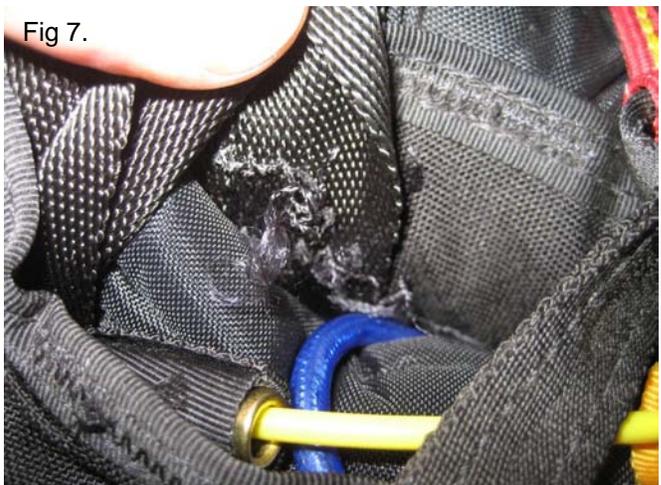
Figures 5, 6 and 7 show example of failing stitch patterns in need of repair.

If the diagonals are in need of repair, riggers in the field are now authorized and requested to make this zigzag repair using “E” shape stitch pattern. This “E” shape zigzag stitch pattern is the same pattern that has been in use on the Sigma Tandem system for some time.
