Service bulletin – Materiell

SERVICE BULLETINE – 2008- 3

Date: 31 March 2008	Service Bulletin #: 08325	# of pages: 6
Subject: Mid-flap stiffener update and main packing addendum		
Status: Recommended

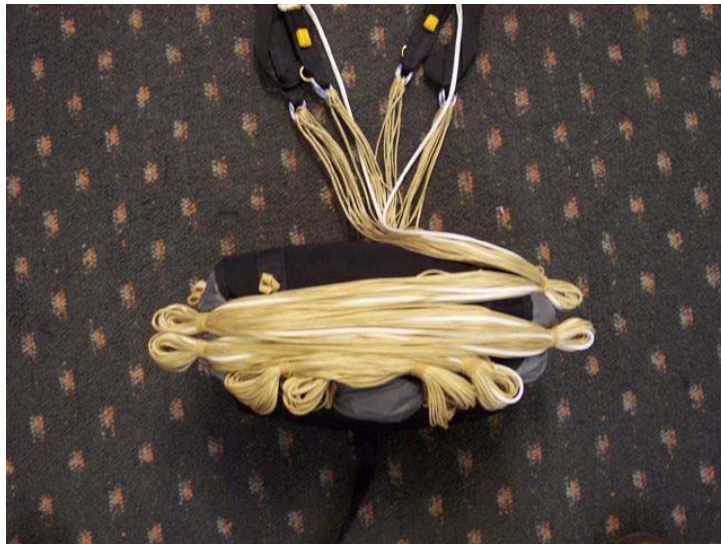
Affected:

This packing method only affects individuals using the outside line stows, not the center line stows. Wings recommends the use of the center line stows on all main containers.
