### **SERVICEORDRE – 2010-2**

# PRODUCT SERVICE BULLETIN (REVISED)

**Bulletin number:** SB AMMO050910/2 -This Service Bulletin replaces SB AMMO050910/1-

**Subject:** Mandatory cutter replacement

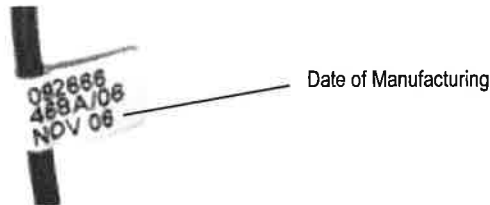
**Identification:** Argus Cutter with manufacturing date Aug. 07 or earlier and manufactured for the Argus AAD by Nobel Energetics

Cutters manufactured as of September '07 use a different, hardened steel blade delivering a clean cut by loops with lesser tension.

The cutter's manufacturing date can be identified by the cable tag:

Systems that have a cutter of the manufacturing date August 07 or earlier must have the cutter replaced with a later model at the next repack but no later than 31 December 2010.

Any senior or master rigger can unscrew the cutter and replace the old cutter with the approved one. The connector must be locked hand tight in order to ensure water resistance.
