Serviceordre – Materieell

SERVICEORDRE – 2018-02

Date: 10 October 2018	Service Bulletin #: 081018	# of pages: 6
Subject: RSL with Reserve Boost Mard (Main Assist Reserve Deployment)		
Status: Mandatory

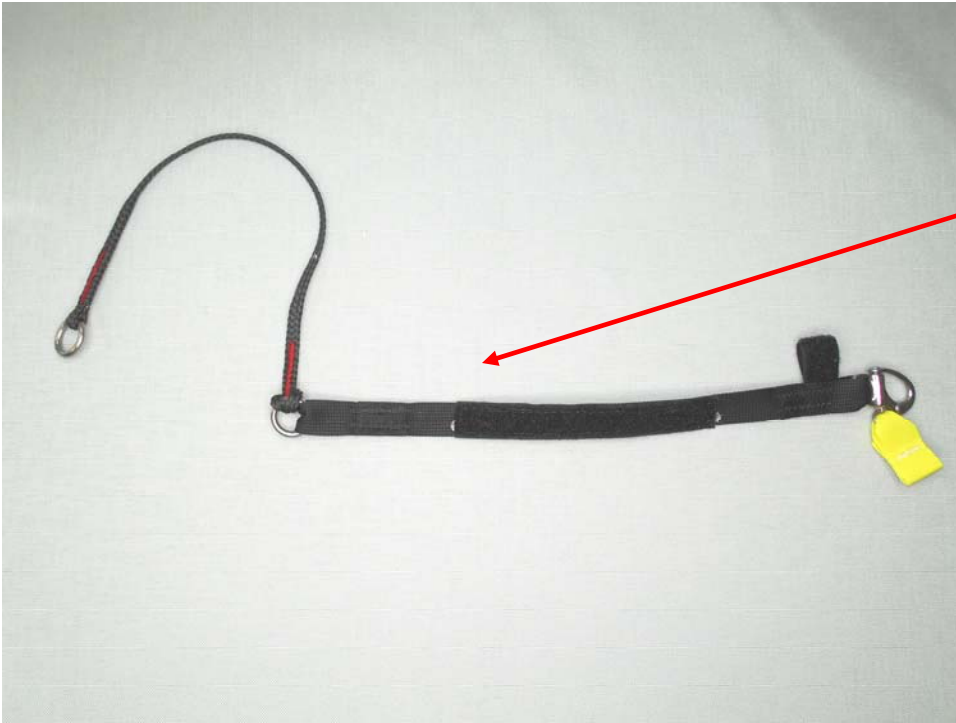
A jumper with the Wings Reserve Boost System had a Reserve Deployment Hesitation involving the Lanyard and Reserve Ripcord Cable. After evaluation of the incident we have decided to modify the Reserve Boost Assembly. This modification is **Mandatory** on or before your next reserve repack. Please see the pictures with text and follow these instructions to modify your Reserve Boost to the new configuration.

Original RSL for “Reserve Boost” on ***Wings*** Reserve Containers.

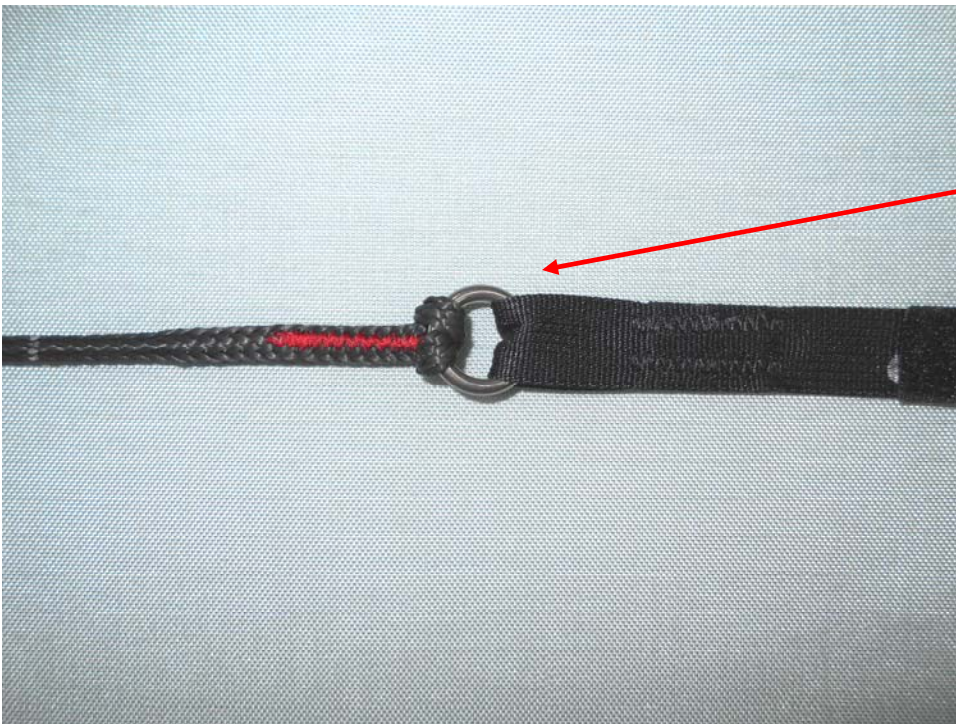
Notice “Lark’s Head” knot on the ring.
