## **Rapport nr. 9/2020**

Dato: 18.06.2020  
Type hendelse: Ulåste rorkoblinger, ufullstendig montering  
Fly: Rolladen Schneider LS4, LN-GLG  
Sted: Atna  
Pilot: Fartøysjef  
Vær: IA  
Antall om bord: 1  
Personskader: Nei  
Skader på fly: Nei

## Airworthiness Directive of The Netherlands

**Airworthiness  
Directive  
1993-001/3**

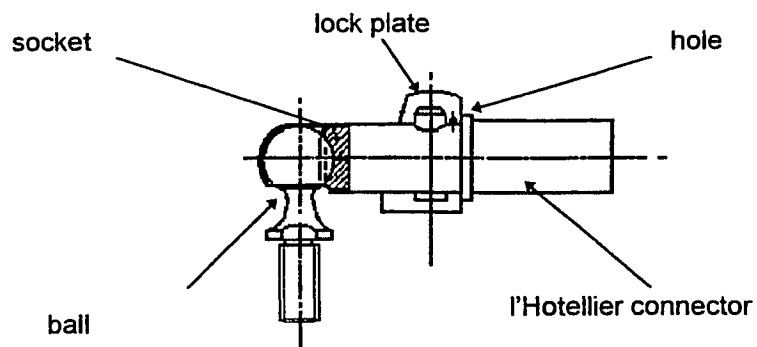
**Section I**

If the connectors are not yet equipped with safety pins (e.g. l'H 140-31 made by Hotellier), these safety pins have to be retrofitted. In certain cases it may become necessary to rebores the hole in the lock plate, which is provided for visual inspection, to  $\varnothing 1.2$  mm so that the safety pin can be inserted.

**Warning!**  
Unsecured ball and socket connectors may open automatically in flight!

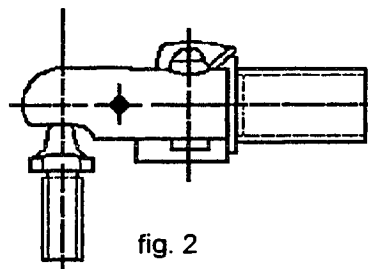
fig. 2

The following systems to secure l'Hotellier ball and socket connectors are LBA-approved: Uerlings sleeves or Uerlings type sleeves (see section III), safety pin (figures 2 and 2a), LS-safety sleeve (figure 3), Schempp-Hirth spring (figure 4) und Wedekind locking system (figure 5).

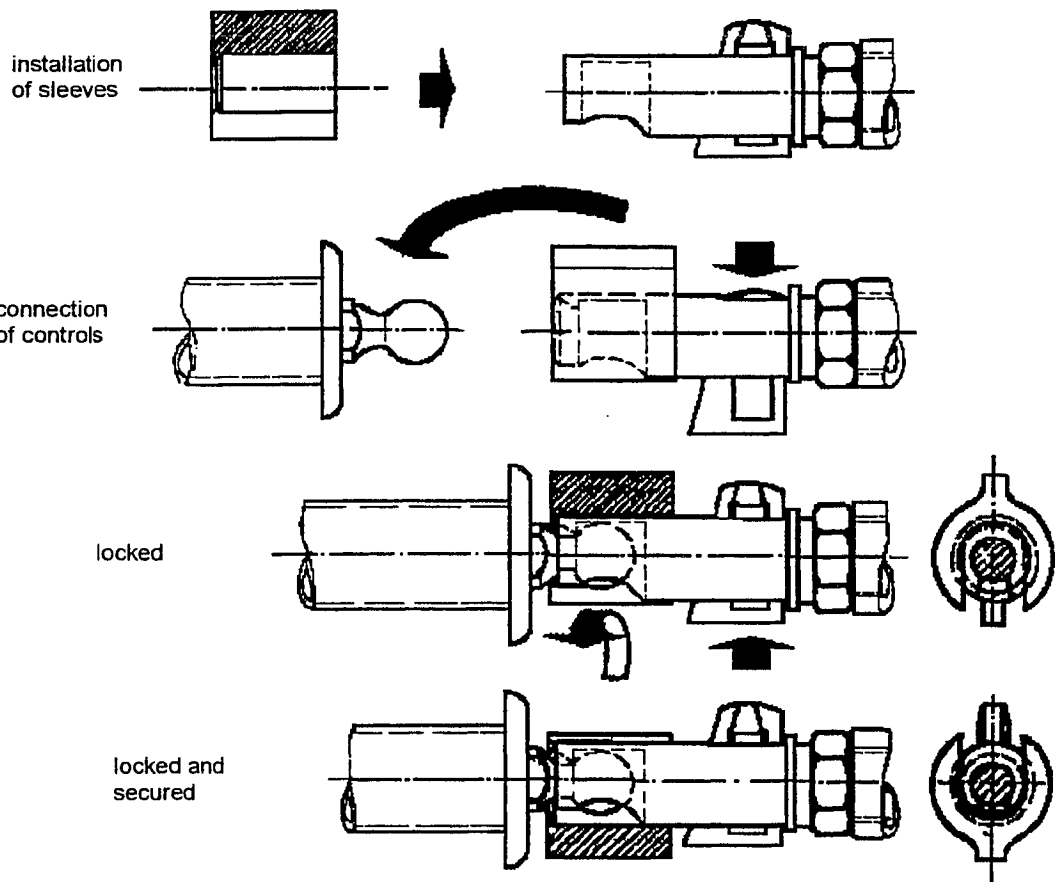
**Section III**

They may by no means be clipped radially onto the l'Hotellier ball and socket connector. Radial clipping (excessive opening of the sleeve) may lead to cracks or ruptures due to overstressing so that the sleeve cannot function properly any more.

For installation, the sleeves have to be slid axially onto the l'Hotellier ball and socket connectors.

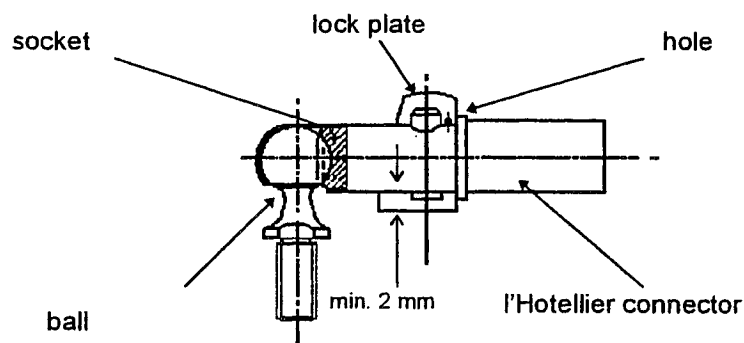
**Section IV**

The socket is to be slid completely over the ball with the lock plate pressed down. During locking the lock plate moves back slightly so that in a correct connection the hole on the narrow edge of the lock plate becomes visible.

Unsecured ball and socket connectors may open automatically in flight.

The safety pin is to be inserted in this hole thus securing the ball and socket connector.

By loading the connection full engagement of the ball is to be verified!

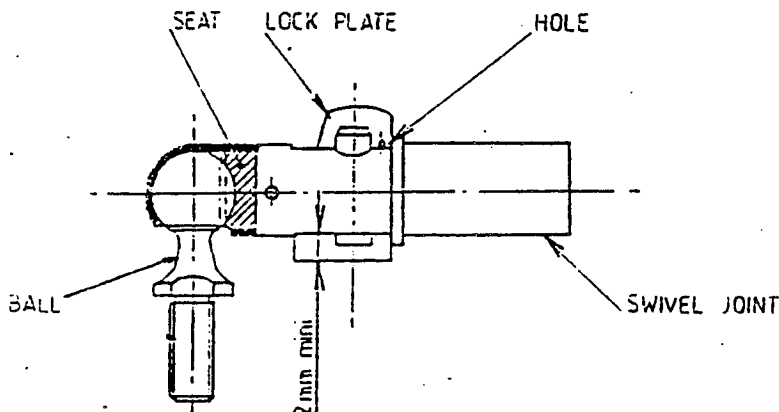
FIG. 1

This projection must be higher than 2 mm.

The aim of this requirement is to verify the efficiency of the automatic take up clearance

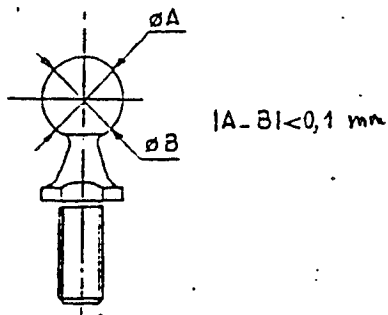
FIG. 2

The variation between several measures of the ball diameter must not exceed 0,1 mm.

This check aim is to detect an abnormal ball wear.
